Geotechnical Investigation of Road Failure Along Abuja- Lokoja Road

A comprehensive investigation of soil properties along the Abuja-Lokoja Road, focusing on samples A and B located between KM51 + 300 to KM51 + 200 and KM45+100 to M51+000 respectively utilizing site analysis, laboratory testing, and comparative analysis, the study identifies critical distinctions in soil composition and engineering behaviours. Sample A, classified as CH (clay of high plasticity), exhibits a moisture content of 12.6% and a density of 1.940 g/cc in contrast, Sample B, classified as GM (gravelly material), has a higher moisture content of 13.8% and a denser structure at 2.100g/cc. Despite differing compositions, both samples demonstrate comparable load-bearing capacities, reflected in California Bearing Ratio (CBR) values at 100% moisture content. Sample A records 32.7% (unsoaked) and 24.6% (soaked), while Sample B exhibits 32.7% (unsoaked) and 26.2% (soaked), indicating similar strength under specific moisture conditions. Further analysis reveals a slightly higher Liquid Limit (LL) for Sample A at 41% compared to Sample B's 40%, with closely aligned Plasticity Index (PI) values, suggesting comparabl

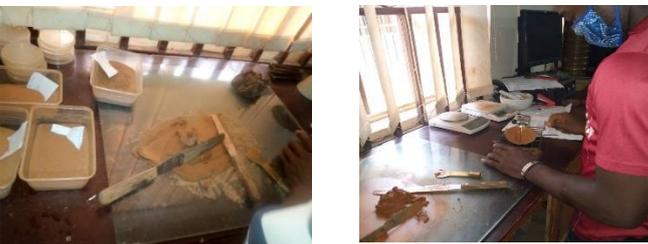
Figure 3: Atterberg Limit test

The Atterberg limit analysis further delved into the intricate transitions between the various states of the soil, namely liquid, plastic, and semi-solid. This in-depth examination provided crucial insights into the soil's plasticity index, aiding in its accurate classification.

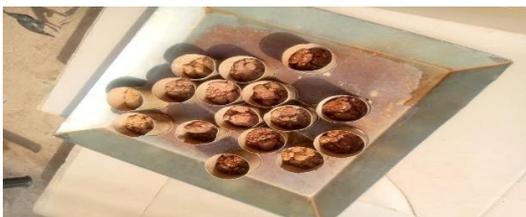
Figure 4: dry can with sample for moisture content determination

The determination of moisture content involved meticulous oven-drying processes, enabling a precise assessment of the water content in the soil. This crucial information contributes to an understanding of how the soil behaves under different moisture conditions.

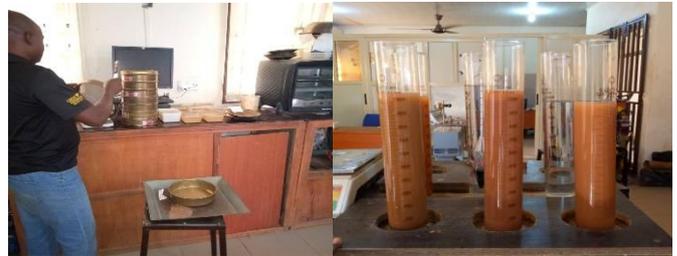
Figure 5: particle size distribution (sieve analysis and hydrometer analysis)

The particle size distribution analysis employed both sieving and hydrometer methods, offering a detailed breakdown of the soil's composition. This granular insight serves as a foundational element for accurately classifying the soil and understanding its engineering properties.

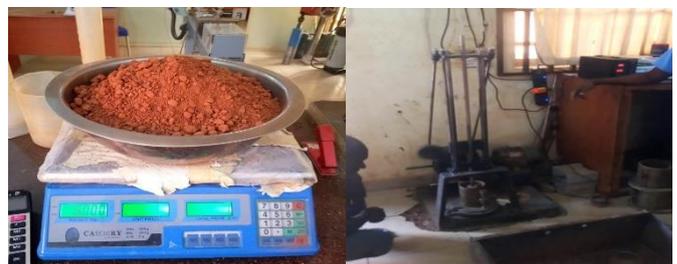
Figure 6: weighing of compaction sample and compaction using automatic compaction machine

The Proctor compaction test unfolded the soil's compaction characteristics, providing essential data on Optimal Moisture Content (OMC) and Maximum Dry Density (MDD). This information is pivotal for comprehending the soil's load-bearing capacity and its response to compaction efforts.

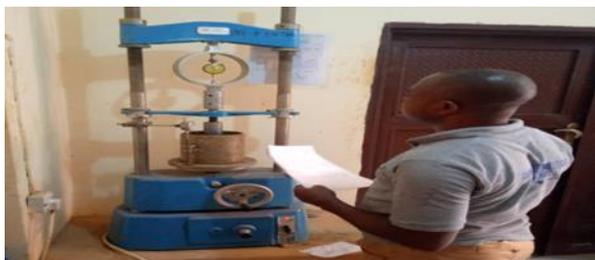
Figure 7: CBR Tests

The California Bearing Ratio (CBR) testing process involved a meticulous classification and evaluation of the soil-subgrade and sub-base course material. The soaking of CBR samples after compaction ensured saturation, and adherence to standardized protocols guaranteed reliable results for pavement design considerations.

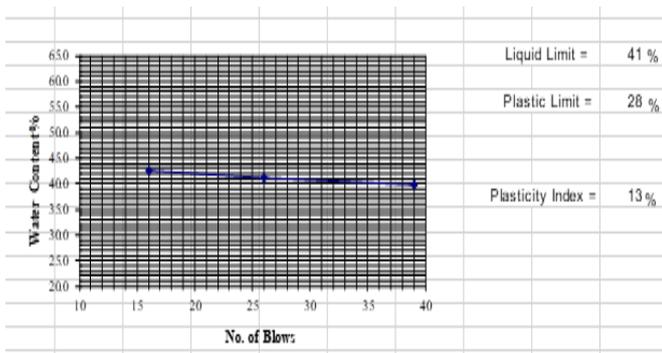
Figure 12: Moisture content Sample A

Sample A, classified as cohesive soil (CH), exhibited clayey characteristics. Laboratory tests revealed moisture content, density, CBR values, and plasticity indices. The findings align with prior research on cohesive soils, emphasizing their plasticity and low permeability. CBR values indicated load-bearing capacity under specific moisture conditions.

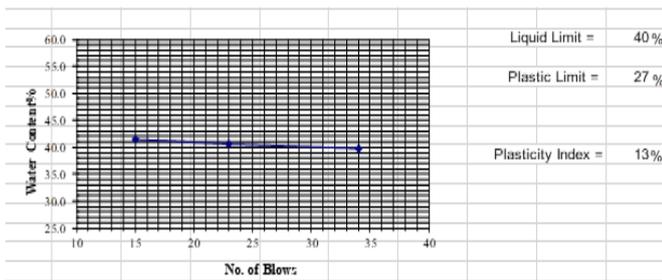
Figure 13: Moisture content Sample B

Sample B, characterized as gravelly soil (GM), displayed gravelly attributes. Laboratory analysis unveiled moisture content, density, CBR values, and plasticity indices. The results align with established literature on gravelly soils, showcasing improved of macadam, geotextile materials, scarification of existing asphalt, and road redesigning, are recommended to bolster road durability and stability. These insights aim to inform sustainable road construction practices and mitigate the influence of dynamic soil behaviour on road integrity. Inconsistencies in relative density pointed to non-uniform soil consolidation. *The CBR are below and at close range to 30%*, It was noted that soils with CBR values below 30% exhibits limited bearing capacity when compared to the Sub base CBR value specified in FMWH (1997) specifications for roads and bridges in Nigeria

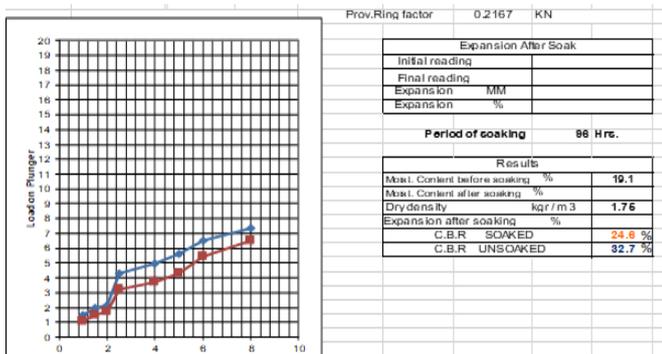
Figure 14: CBR Sample A

The CBR values indicated load-bearing capacity under specific moisture conditions.

The comparison between Sample A and Sample B highlights differences in soil compositions but similar load-bearing capacities. Despite higher clay content in Sample A, both samples exhibited comparable plasticity characteristics and CBR values. This underscores the necessity of precise consideration of soil variations for optimal construction practices. The geotechnical investigation along the Abuja-Lokoja Road has provided valuable insights into soil behaviour and its implications for road construction. The data analysis highlights the need for tailored construction strategies to address the diverse and heterogeneous nature of soil properties. These findings contribute to informed decision-making in road construction and maintenance, emphasizing the importance of a holistic understanding of soil behaviour.

- i. Customized Engineering Solutions: Tailor construction plans to accommodate the specific soil properties identified in Sample A and Sample B for improved stability and performance.
- ii. Advanced Geotechnical Investigations: Conduct additional geotechnical studies to explore deeper layers and assess the potential impact on road integrity.
- iii. Hydrological Assessments: Investigate the influence of water flow and drainage patterns on soil stability to mitigate erosion and flooding risks.
